Operating Experience Weekly Summary 97-29

July 11 through July 17, 1997

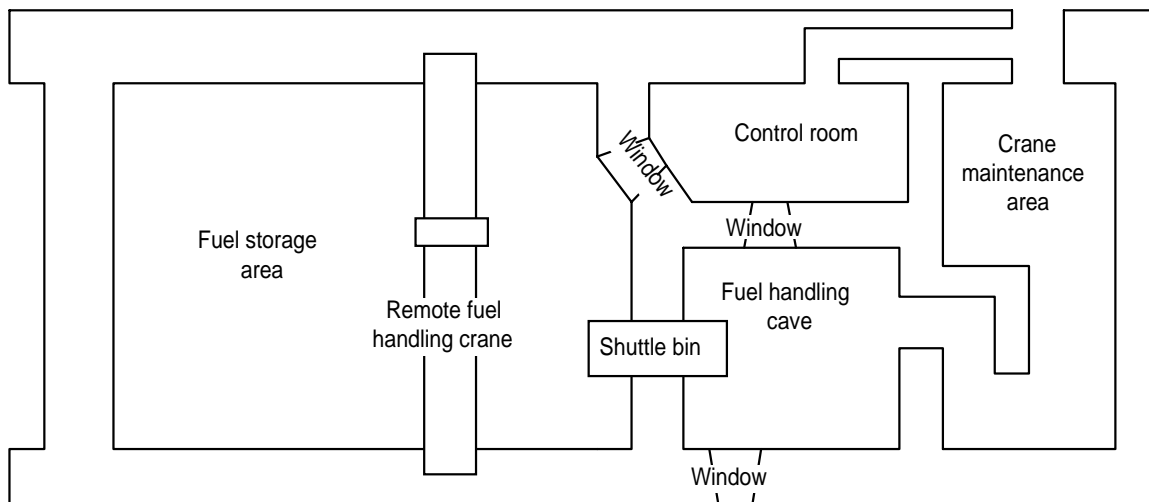
Figure 1-1. Layout of the Irradiated Fuel Storage Facility

Investigators determined that fuel-handling personnel were moving the canister from the fuel-handling cave to its designated storage location in the fuel storage area. They placed a lid on the canister in the cave and moved it to the fuel storage area using the shuttle bin. They lifted the canister from the shuttle bin and attempted to store it in storage racks using the overhead crane. Investigators have not yet determined if either the canister or the concrete floor was damaged. Figure 1-1 shows the layout of the Irradiated Fuel Storage Facility.

Operators use a remote fuel-handling crane to move fuel canisters in the fuel storage facility. Personnel perform the operations remotely, viewing movement of the crane through a 4 foot by 4 foot window in the control room. A crane-mounted camera provides some additional visibility. The crane contains a motor-operated latching device that engages directly to the bale on the canister. The bale is on the canister lid, and the lid is locked in place. However, because of the angle of the latching device relative to the viewing angles, the operators could not see if the device was completely engaged.

Although the investigation is continuing, investigators have determined that the camera needs to be re-installed for better operator viewing. This is the second event at Idaho where the corrective actions included evaluating modifications to this camera for better viewing. NFS reported the first event in Weekly Summary 95-44. On October 26, 1995, operators violated a technical standard when they failed to verify identification of a fuel storage canister before moving it. As a result, they retrieved the wrong canister. Investigators determined that the camera position on the crane was poorly designed and was a contributing cause to the event. However, after evaluating proposed modifications to the camera, investigators determined that the cost was not justified. (ORPS Report ID—LITC-FUELCSTR-1995-0012)
